A PEER REVIEW

Washington Metropolitan Area Transit Authority Washington, DC

JULY 2016

THIRD RAIL POWER & INFRASTRUCTURE PROVIDED AT

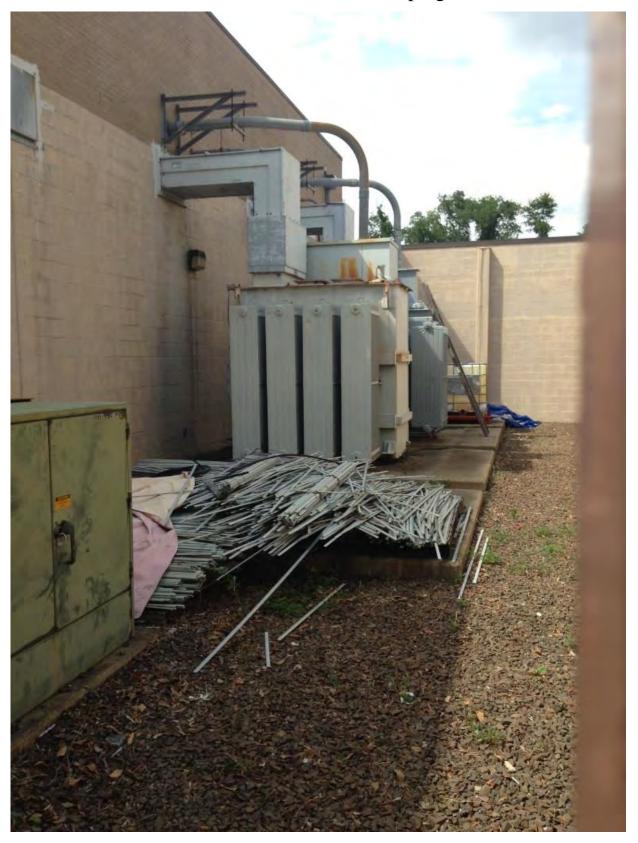
Photo 1: Traction Power Substations Housekeeping

A site visit to one of the traction power substations found debris was staged with tape material stored outside the room next to a transformer currently out of service. Breakers on floor were racked out for line-up out of service. Breakers removed for extended periods are preventative maintenance checked prior to being put back in service. (See Photo 1)

- i) Housekeeping of traction power substations (TPSS) needs to be improved.
- ii) Ensure that substation equipment is free from dust.
- iii) Remove any unnecessary debris/equipment not relevant to DC Traction power substation.
- iv) Properly protect circuit breakers that are racked out of the switchgear.
 Dust, dirt and debris on the breaker could potentially lead to equipment failures and arcing within switchgear.
- v) The use of plastic sheeting to protect the gear from roof leaks should be discouraged.
- vi) Building infrastructure should also be included in preventative maintenance cycles.
- vii) WMATA to verify that TPSS preventative maintenance procedures being performed meets industry standards and best practices.

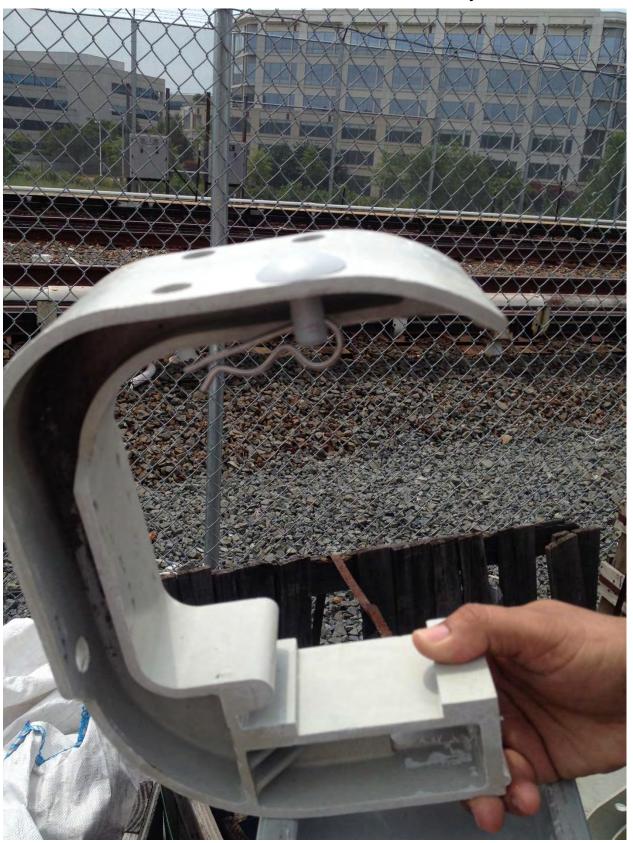
Photo 2: Third Rail Cover Board Securement Assembly

The team's visual observations of sample cover board assemblies with regards to securement are considered adequate. The method of securing these cover boards is with a mushroom type button threaded from the top of the cover board and fastened with a cotter pin under the board. While this method is considered adequate, it does pose difficulties when carrying out inspections to verify that the cotter pin is in place and secure. Some agencies have the mushroom button threaded from under the board and secured with a nut on top. (See Photo 2 for traction power cover board securement assembly). We also found several areas where cover boards were missing.

- a) Verify that all traction power third rail cover boards are made of low smoke zero halogen materials in accordance with NFPA³ 130.
- b) Identify the causal factors why several cover boards are failing and have a plan to address issues.
- c) Research alternative means of securement of cover boards in order to facilitate inspection of the securement method.

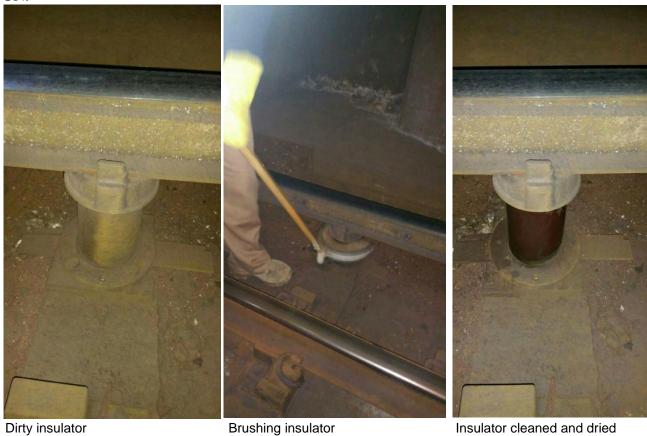
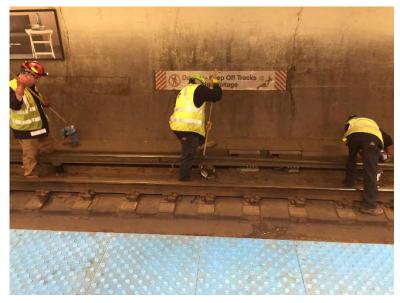
Photo 4: Cleaning of Third Rail Insulators

Third rail insulators were found to be excessively contaminated in the yard and on open deck areas. Soiled insulators result in a higher likelihood of arcing and a point of failure. (See Photo 4 for a cleaning method employed by one transit agency).

Example of how one transit agency cleans their third rail insulators with traction power switched ON.

Crew working with flaggers

Develop a more robust and comprehensive track cleaning programs for drains, track beds, tunnels walls, insulators etc.

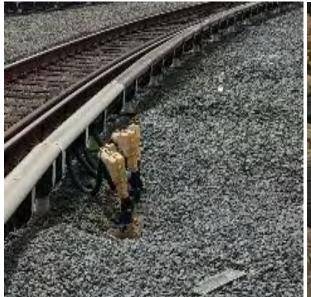
Yard curve with cover board and boots showing wear/age possibly UV issue.

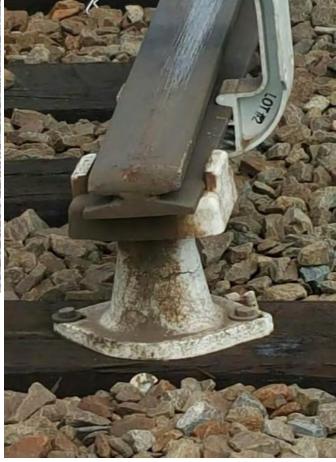
Third rail end with cracked insulator – possibly load imbalance due to curve.

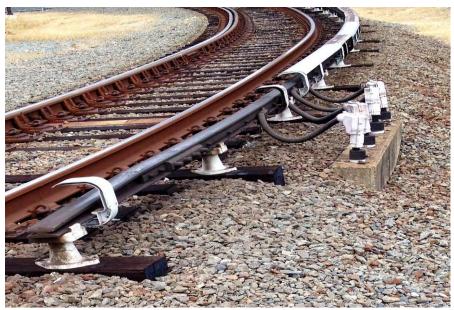
Shows missing cover board and connection.

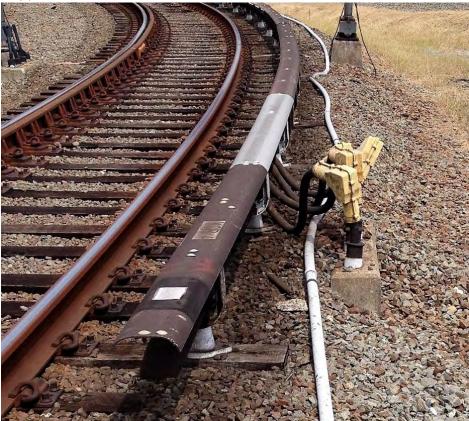
Shows boots and how they leave duct. Some droop-weight can cause weakening over time due to heat.

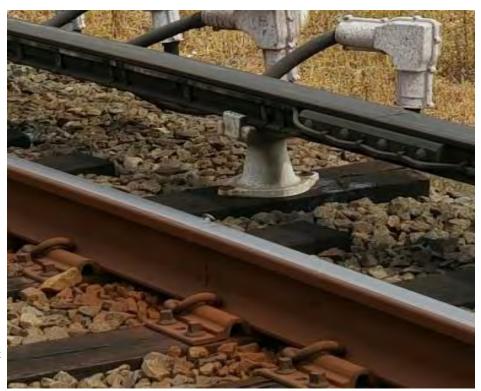
Third rail heat and joint bars.

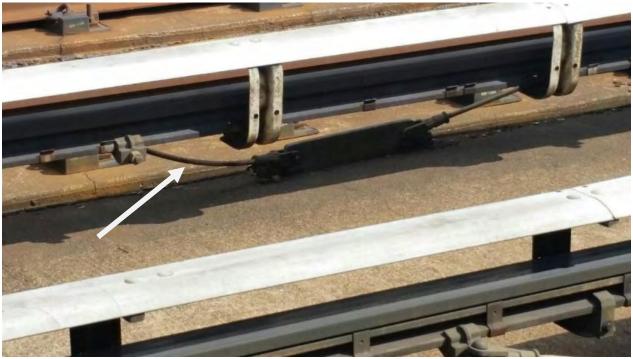
Contact rail anchor improper installation, anchor is bowing due to improper placement of connection on third rail.

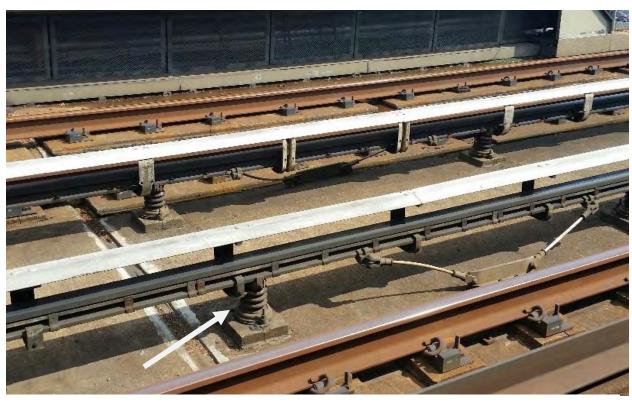
It was noted that the insulators seemed to be excessively contaminated, even in the yards and open deck track areas. Soiled insulators result in a higher likelihood of arcing and a point of failure.

Dirty insulator.

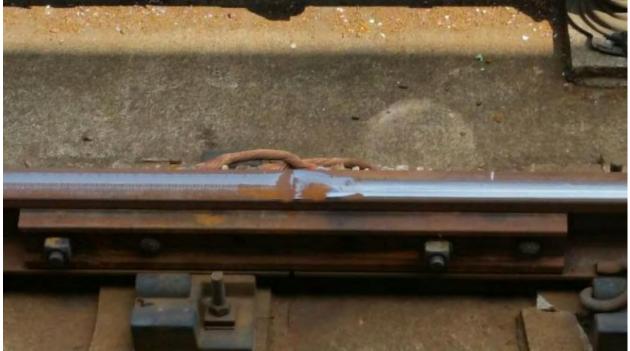
Running Rail Joint "C" bond, appears to be in good condition.

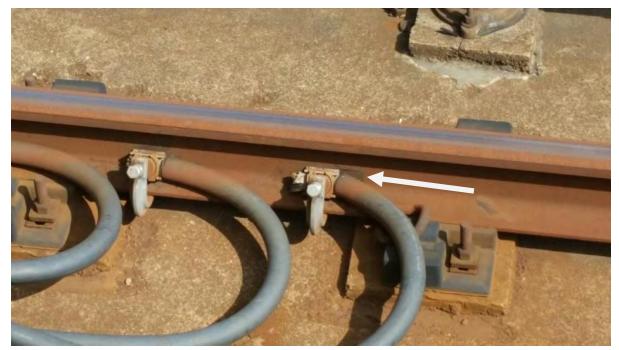
Signal cable clamped to rail, appears to have been in place for extended period of time. One clamp shows movement on rail.

Re-evaluate the suitability of clamps for use in any cable termination. The peer review team noted that clamps could become loose over time and continuity could be lost due to corrosion. The Polidori Clamps used to attach the ATC (Automatic Train Control) cables to the running rail should only be used for short term correction of deficiencies, until time is available to install a permanent bond to the rail. The loosening of the clamp and corrosion of the connection contribute to stray current corrosion and negatively impact traction return and track/signal circuits.

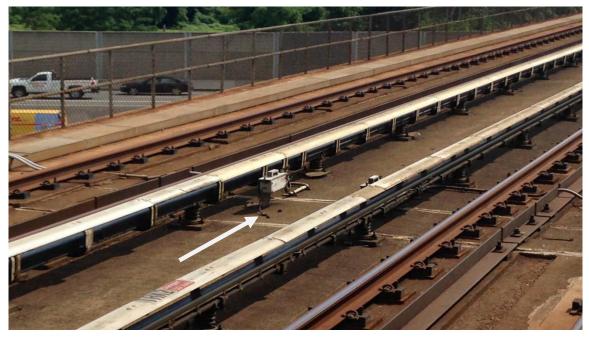
The third rail connection to the heater control panel is off the rail.

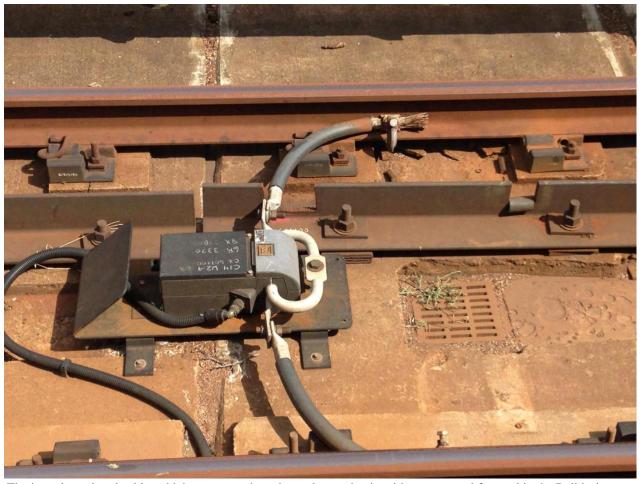
The impedance bond cable, which appears to have been short to begin with, was moved forward in the Polidori Clamp making it even shorter thereby further limiting the cable to move with the thermal expansion joint.
